Debris/Ice/TPS Assessment and Integrated Photographic Analysis for Shuttle Mission STS-57

(NASA-TM-107562) DEBRIS/ICE/TPS
ASSESSMENT AND INTEGRATED
PHOTOGRAPHIC ANALYSIS FOR SHUTTLE
MISSION STS-57 Final Report, 18
Jun. - 2 Jul. 1993 (NASA) 131 p

DEBRIS/ICE/TPS ASSESSMENT
AND
PHOTOGRAPHIC ANALYSIS
OF
SHUTTLE MISSION STS-57

June 21, 1993

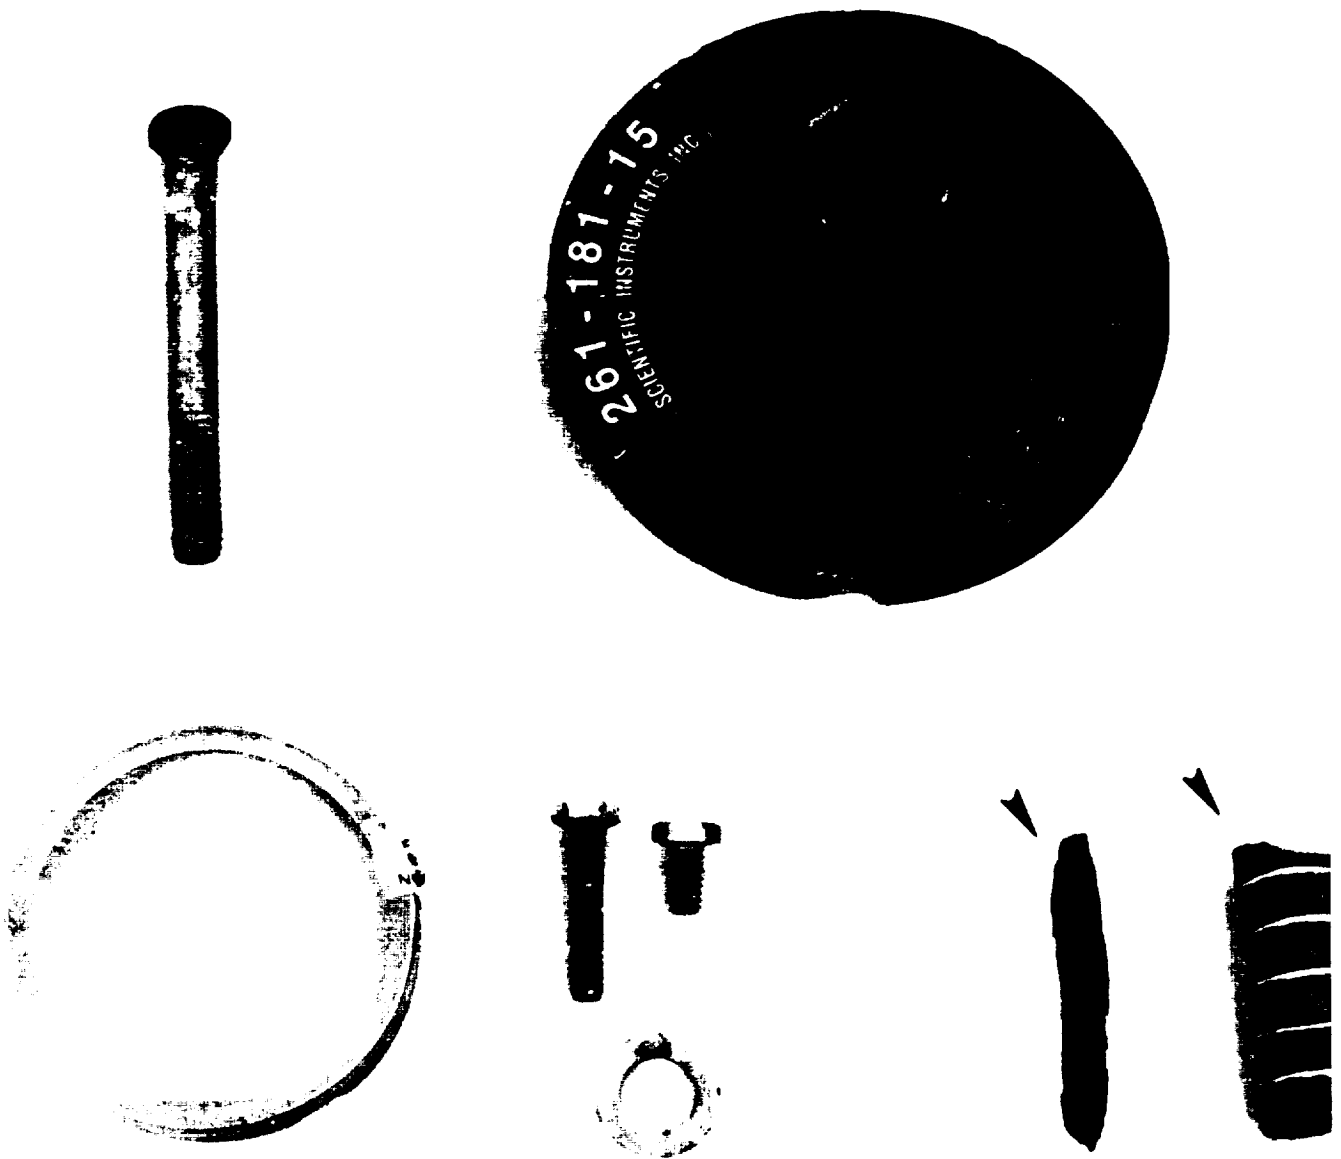
A frangible nut web, 2-1/4" by 5/16", was found on the stud in holddown post #2. A Q-felt plug from the Orbiter base heat shield was found on the southwest pad apron.

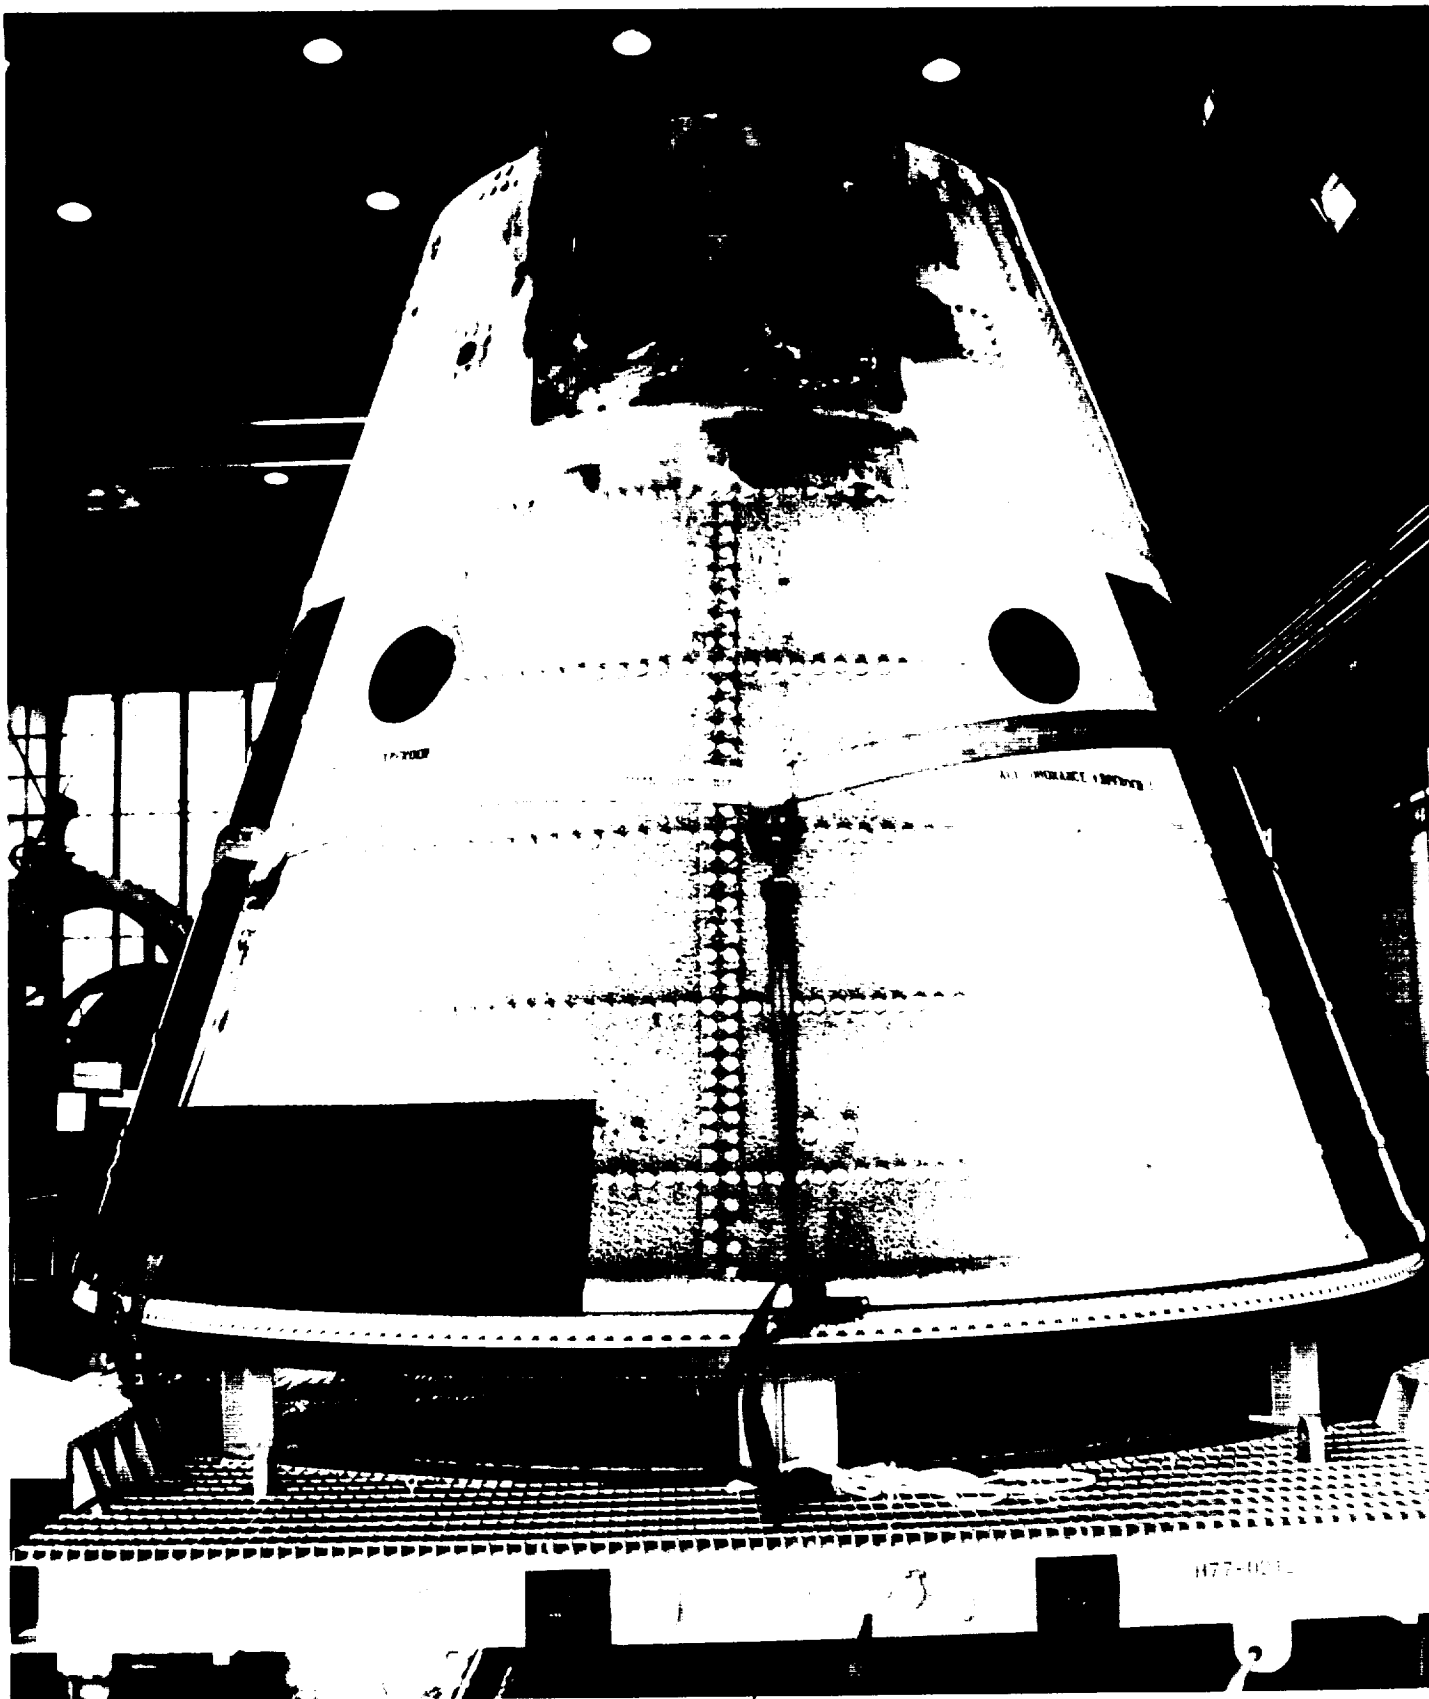
The RH frustum had 46 MSA-2 debonds over fasteners and two areas of missing MSA-2. All BSM aero heatshield covers were locked in the fully opened position, though the two left cover attach rings had been bent by parachute riser entanglement.

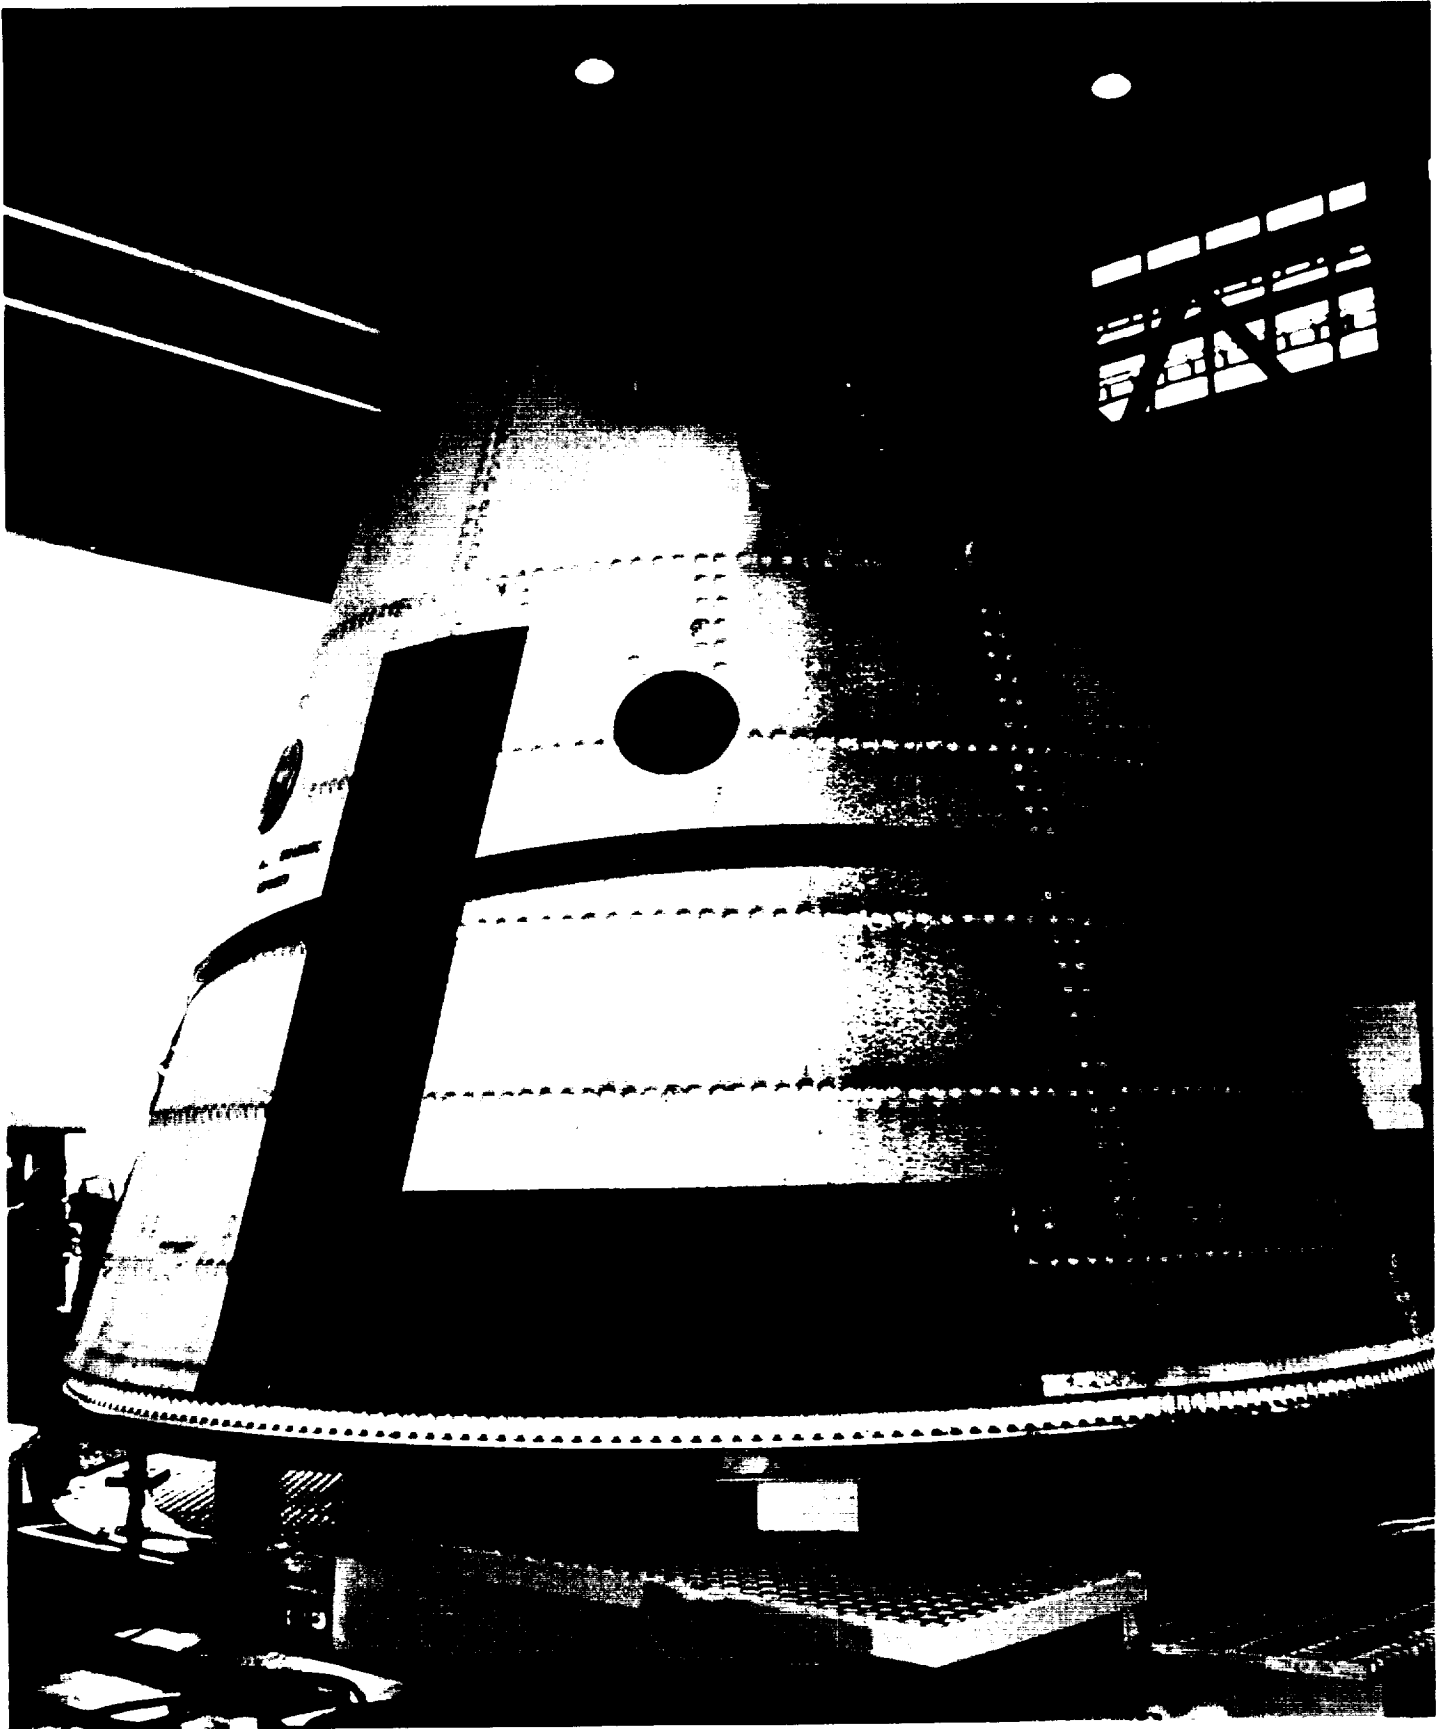
The LH frustum had a total of 27 MSA-2 debonds over fasteners. The BSM aero heat shield covers were locked in the fully opened position.

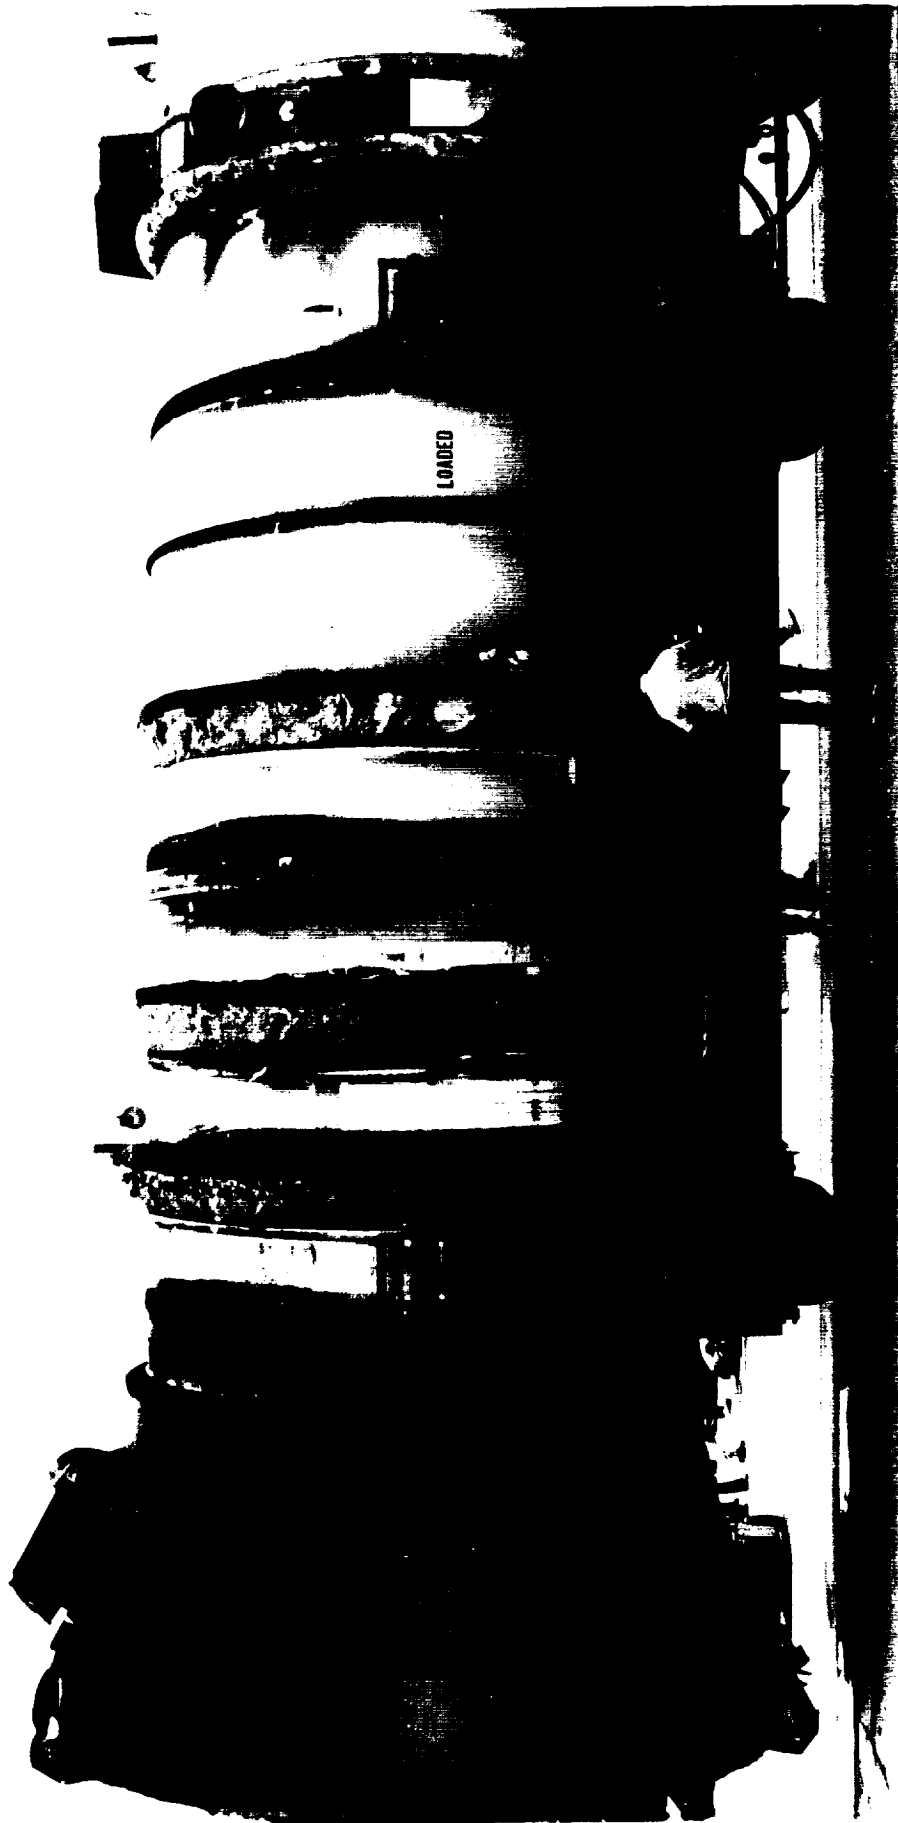
Post flight condition of the LH aft booster and aft skirt. The ET/SRB aft struts, ETA ring, IEA, and IEA covers appeared undamaged. All three aft booster stiffener rings were damaged by water impact.

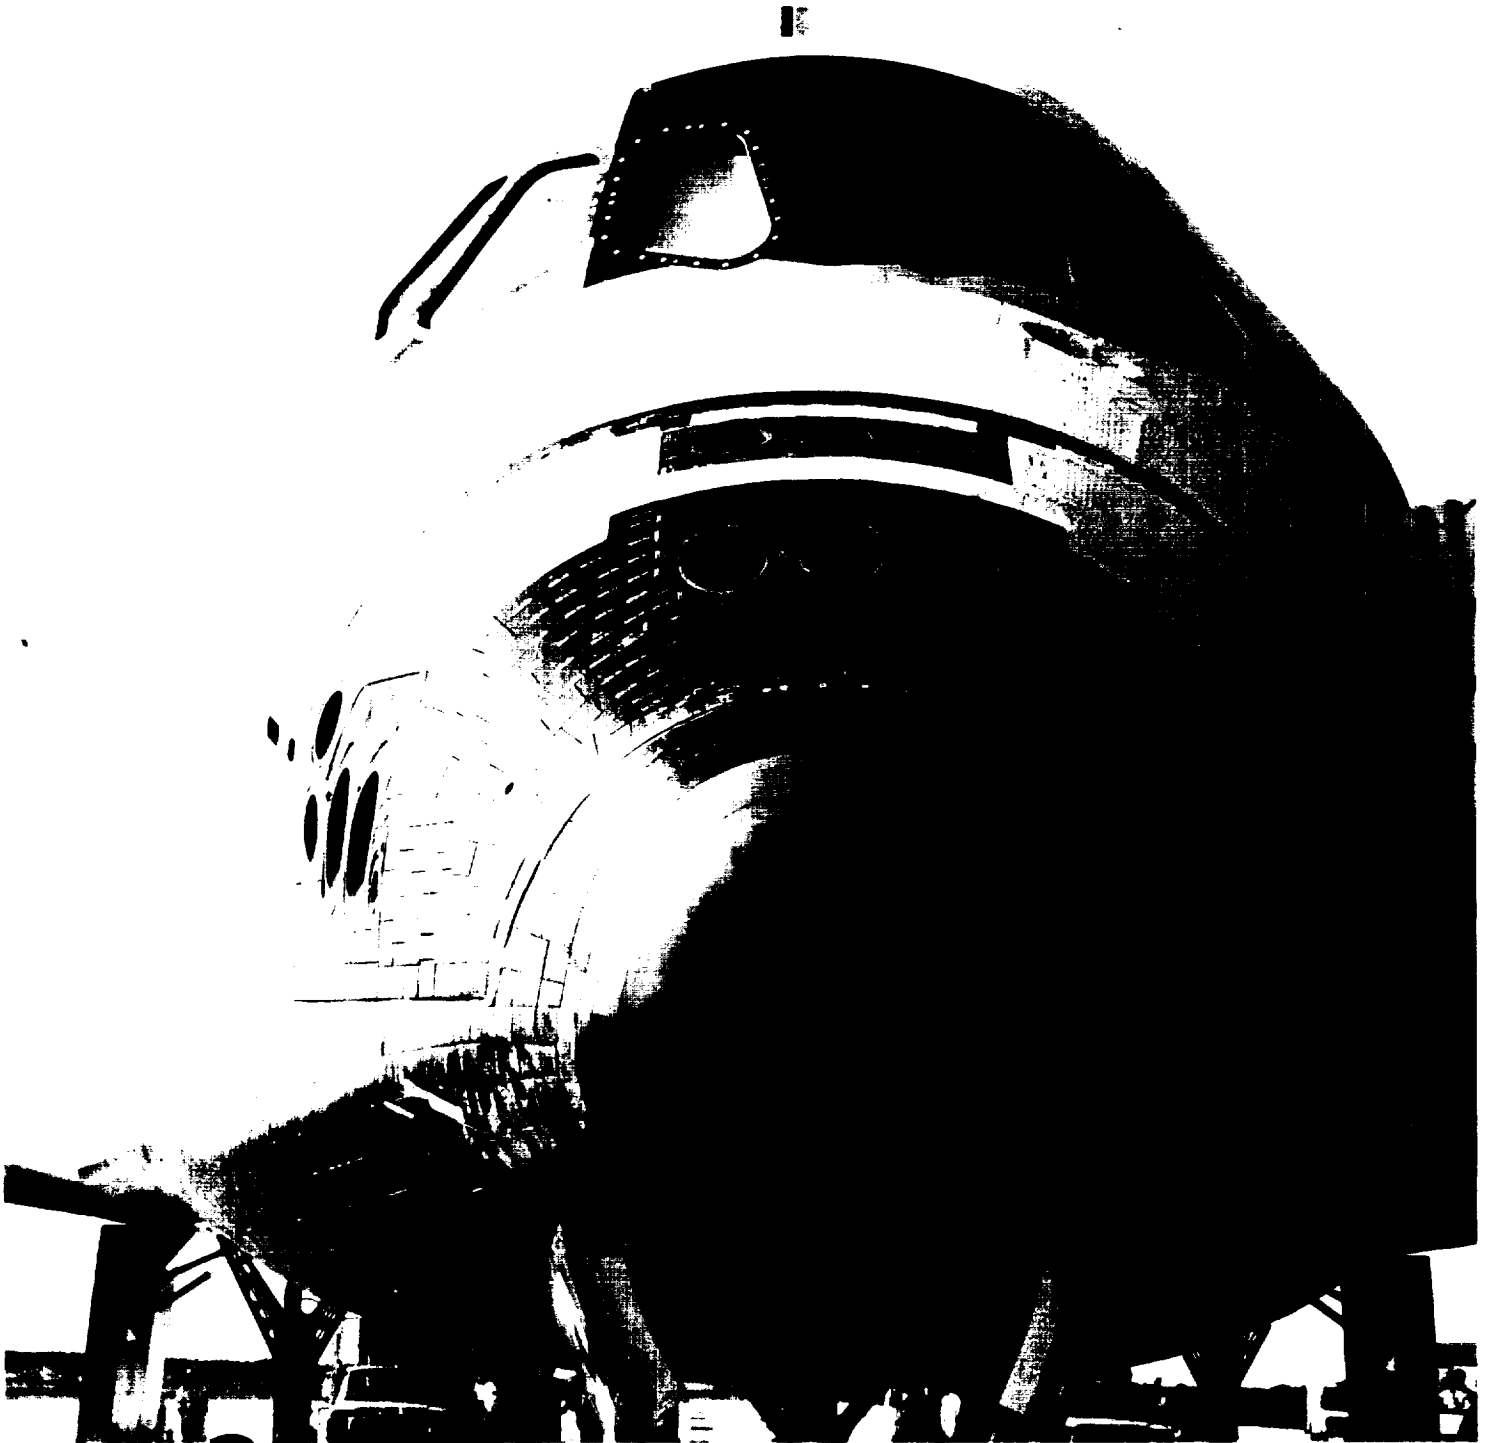
Overall view of the Orbiter nose. Forward facing windows were moderately hazed. Note discoloration of the AFRSI near the F3D and F1F thrusters.

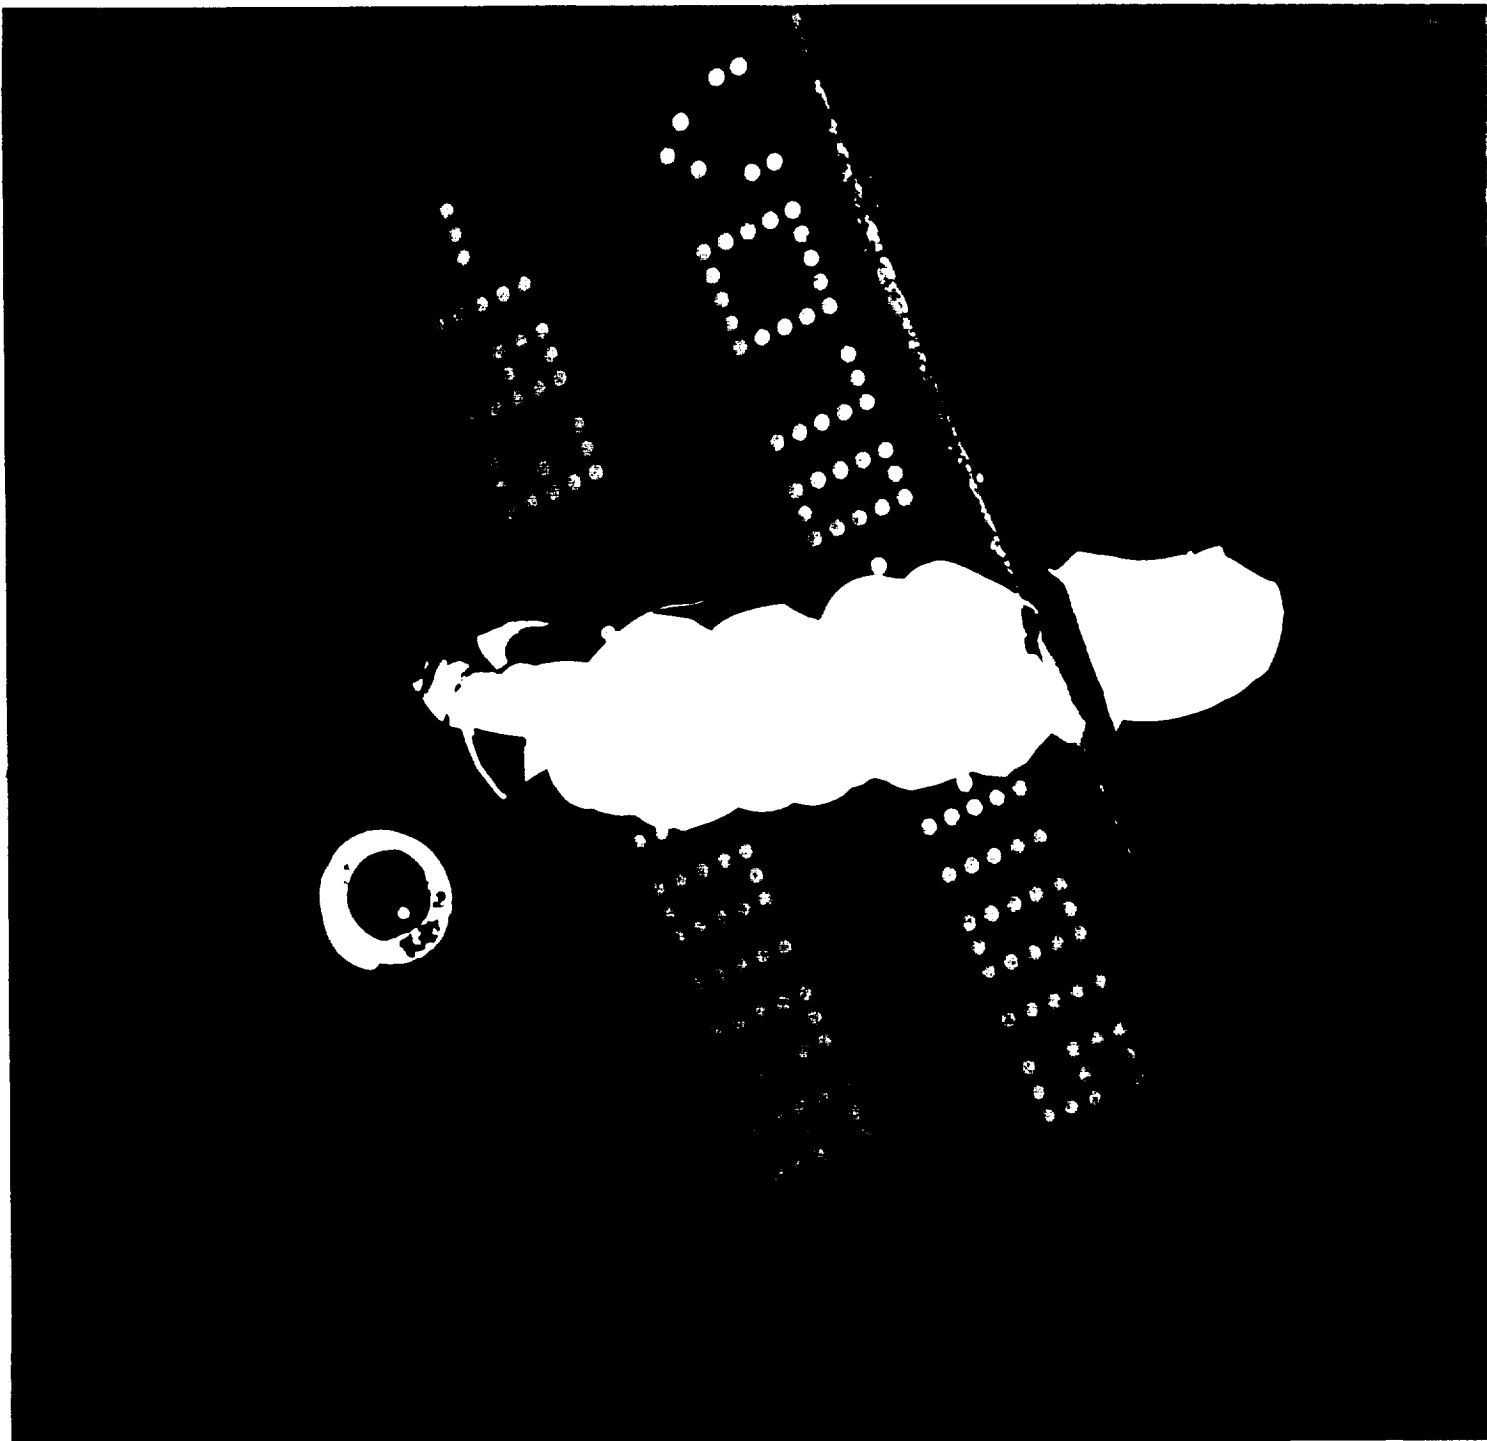
The Orbiter lower surface sustained a total of 75 hits. The largest tile damage site measured 3.5" x 0.75" x 0.375" and was located on the RH lower surface outboard of the nose landing gear door.

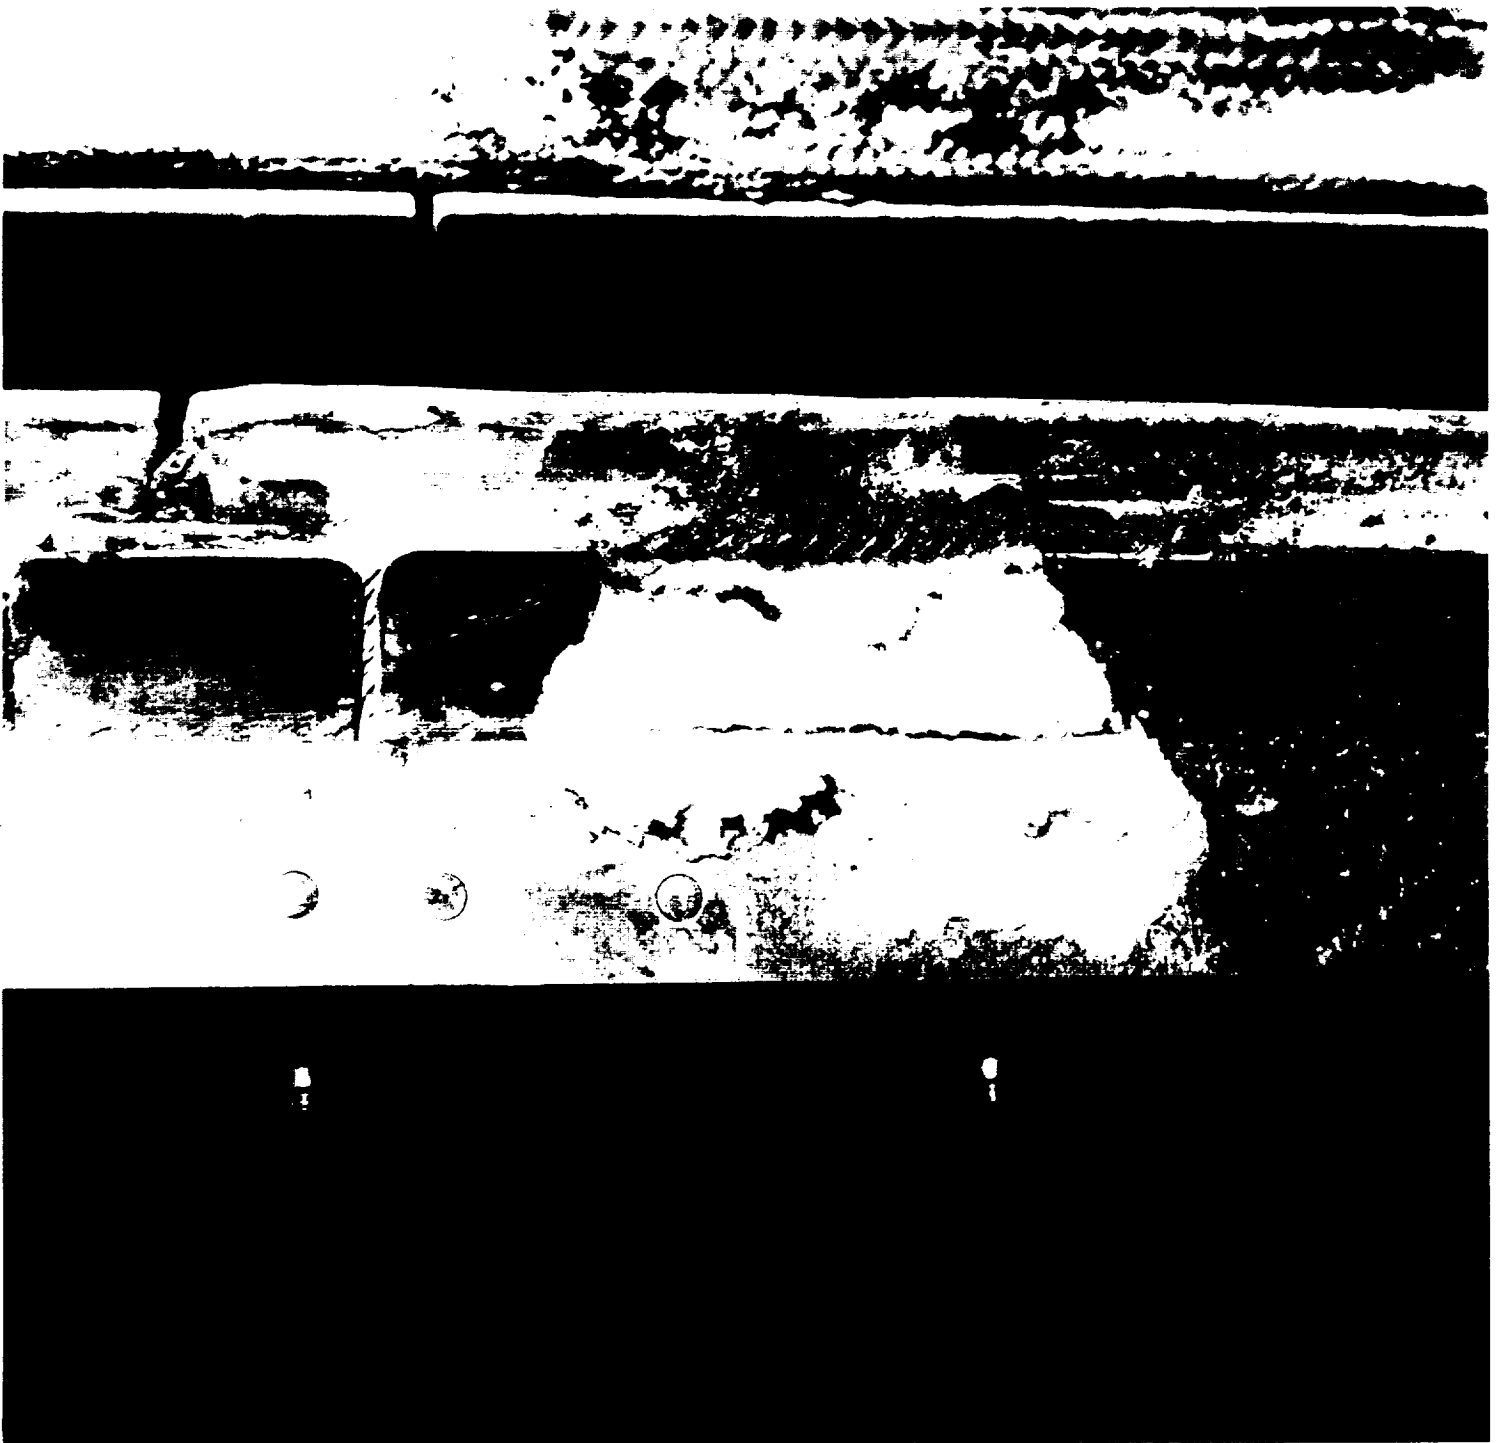
Visual inspection of the right ET door (LO2 side) revealed a 3" x 1" piece of foam adhering to a tile near the hinge line. The foam had been compressed into the thermal barrier when the door was closed, but apparently did not affect the seal.

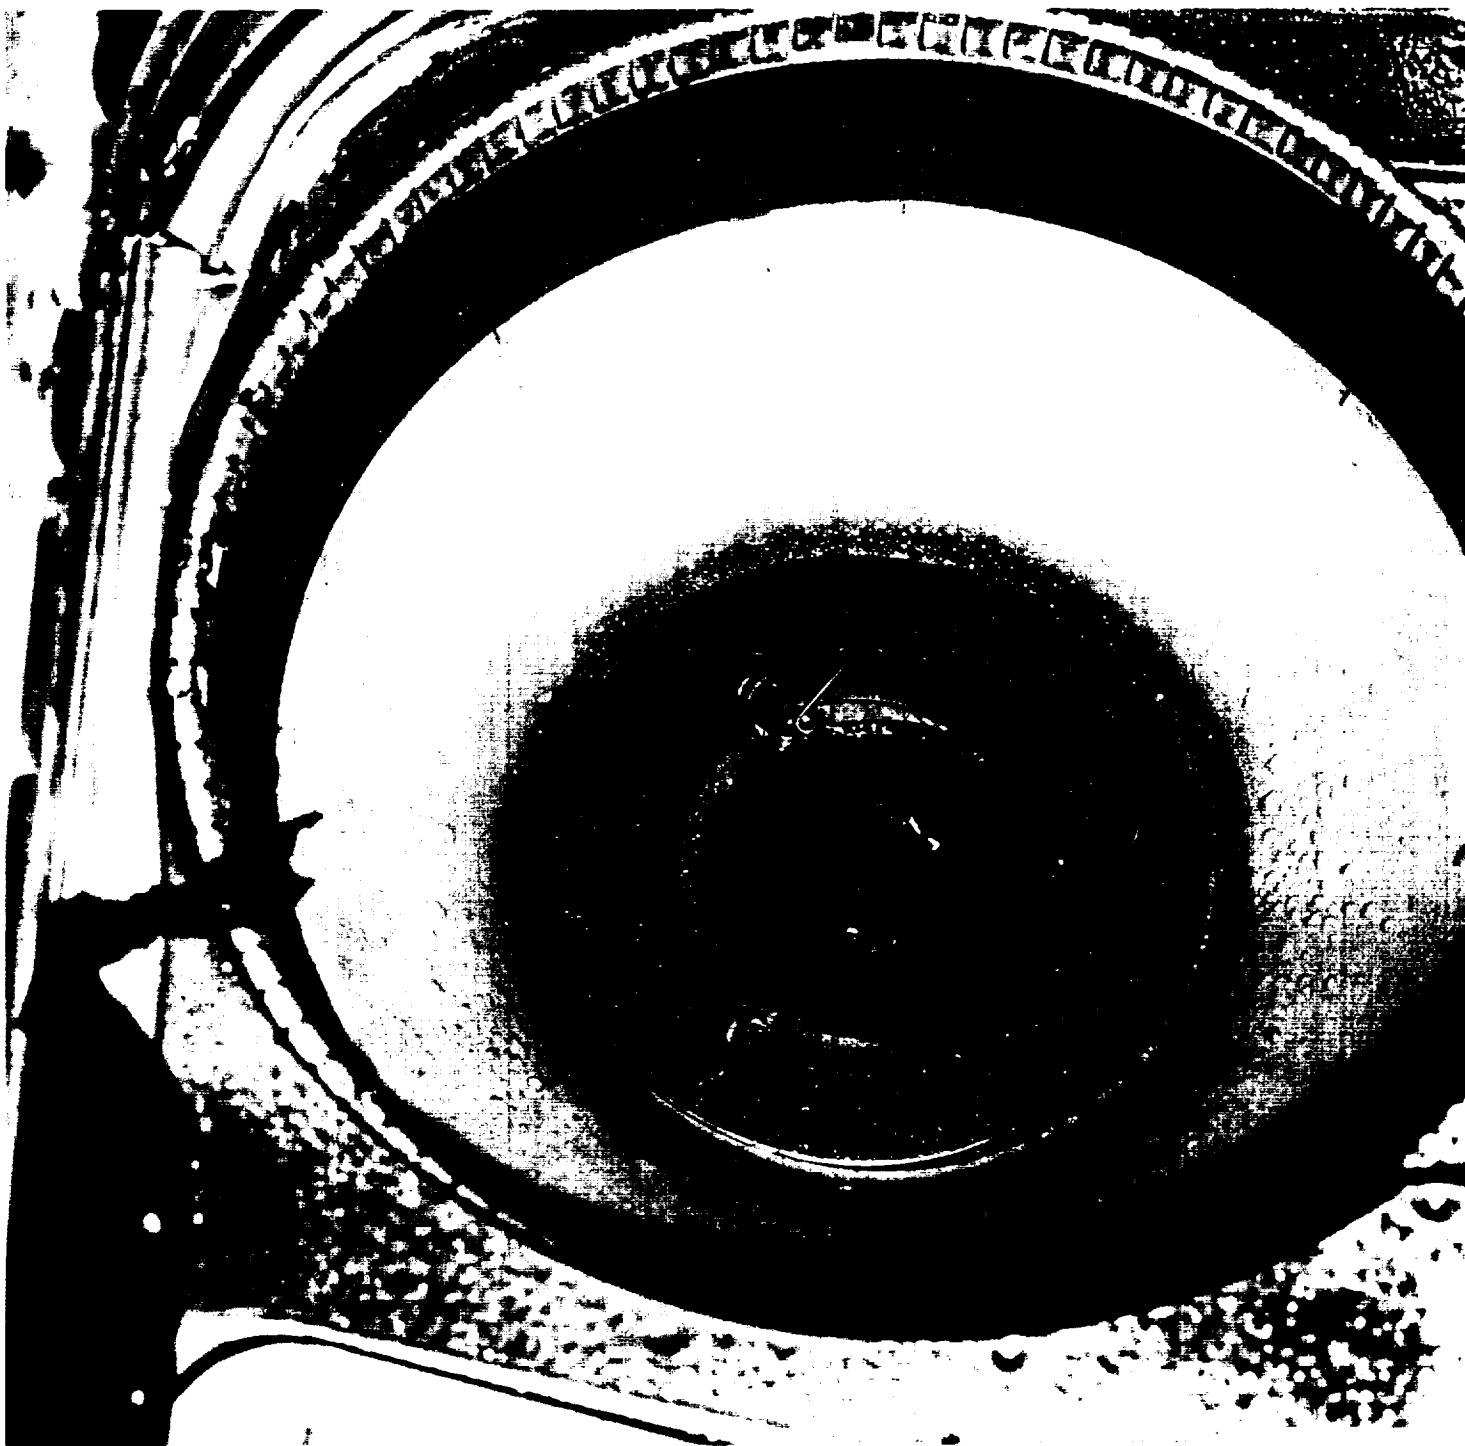
The left ET/ORB attach point (EO-2) hole plugger had not seated and was obstructed by ordnance fragments

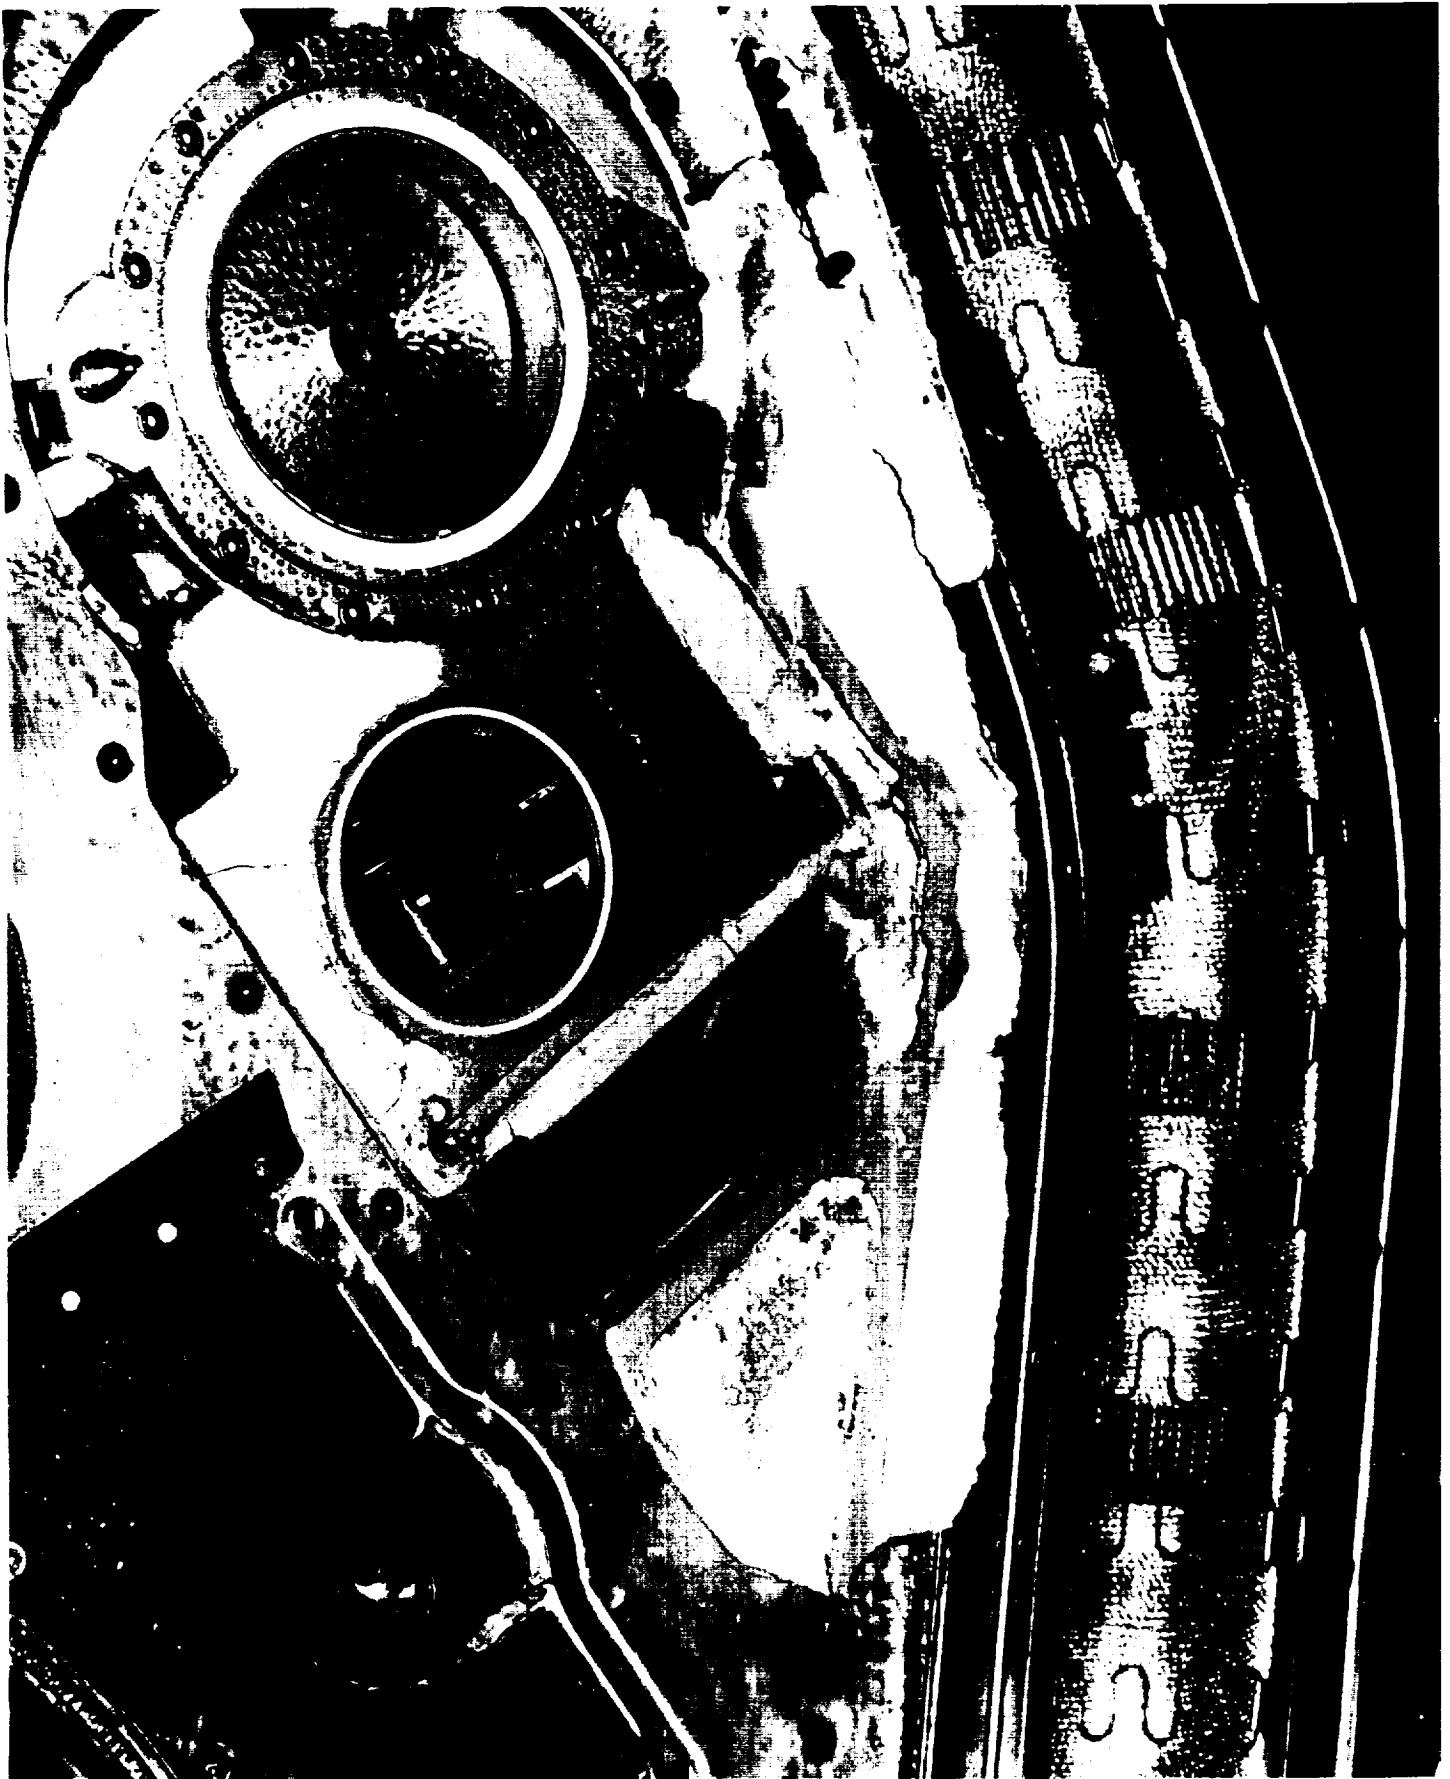
A 15-inch long piece of foam with red purge seal, which should have remained with the ET during separation, adhered to the LH2 ET/ORB umbilical near the 4-inch flapper valve.

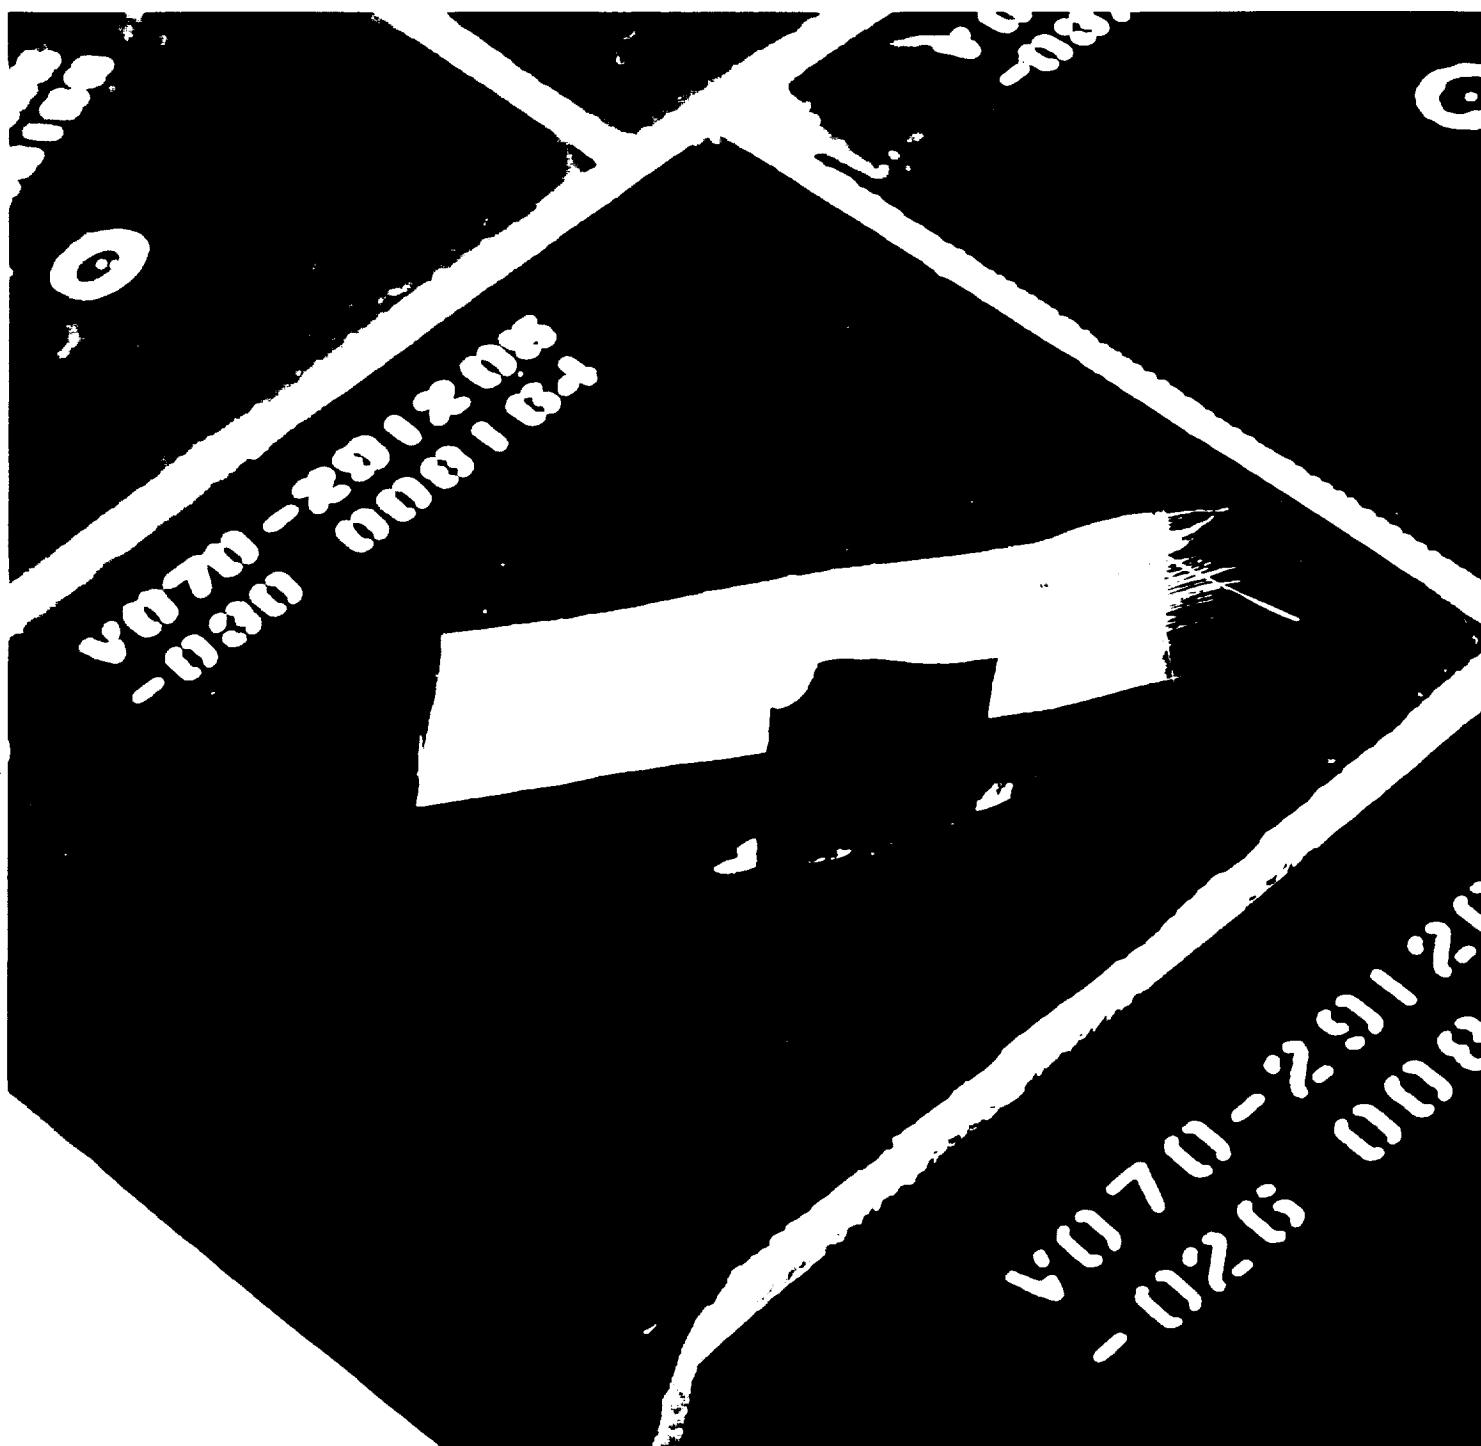
A 2" x 1" piece of metal spring was embedded in a tile
on the vertical stabilizer stinger near the hinge
